**LIMITED PRE-DEMOLITION HAZARDOUS MATERIALS AND LEAD-BASED PAINT
ASSESSMENT REPORT**

**141 W. WOOLCOCK STREET
JEFFERSON, WISCONSIN**

JEFFERSON COUNTY HIGHWAY DEPARTMENT

PROJECT REFERENCE #15216

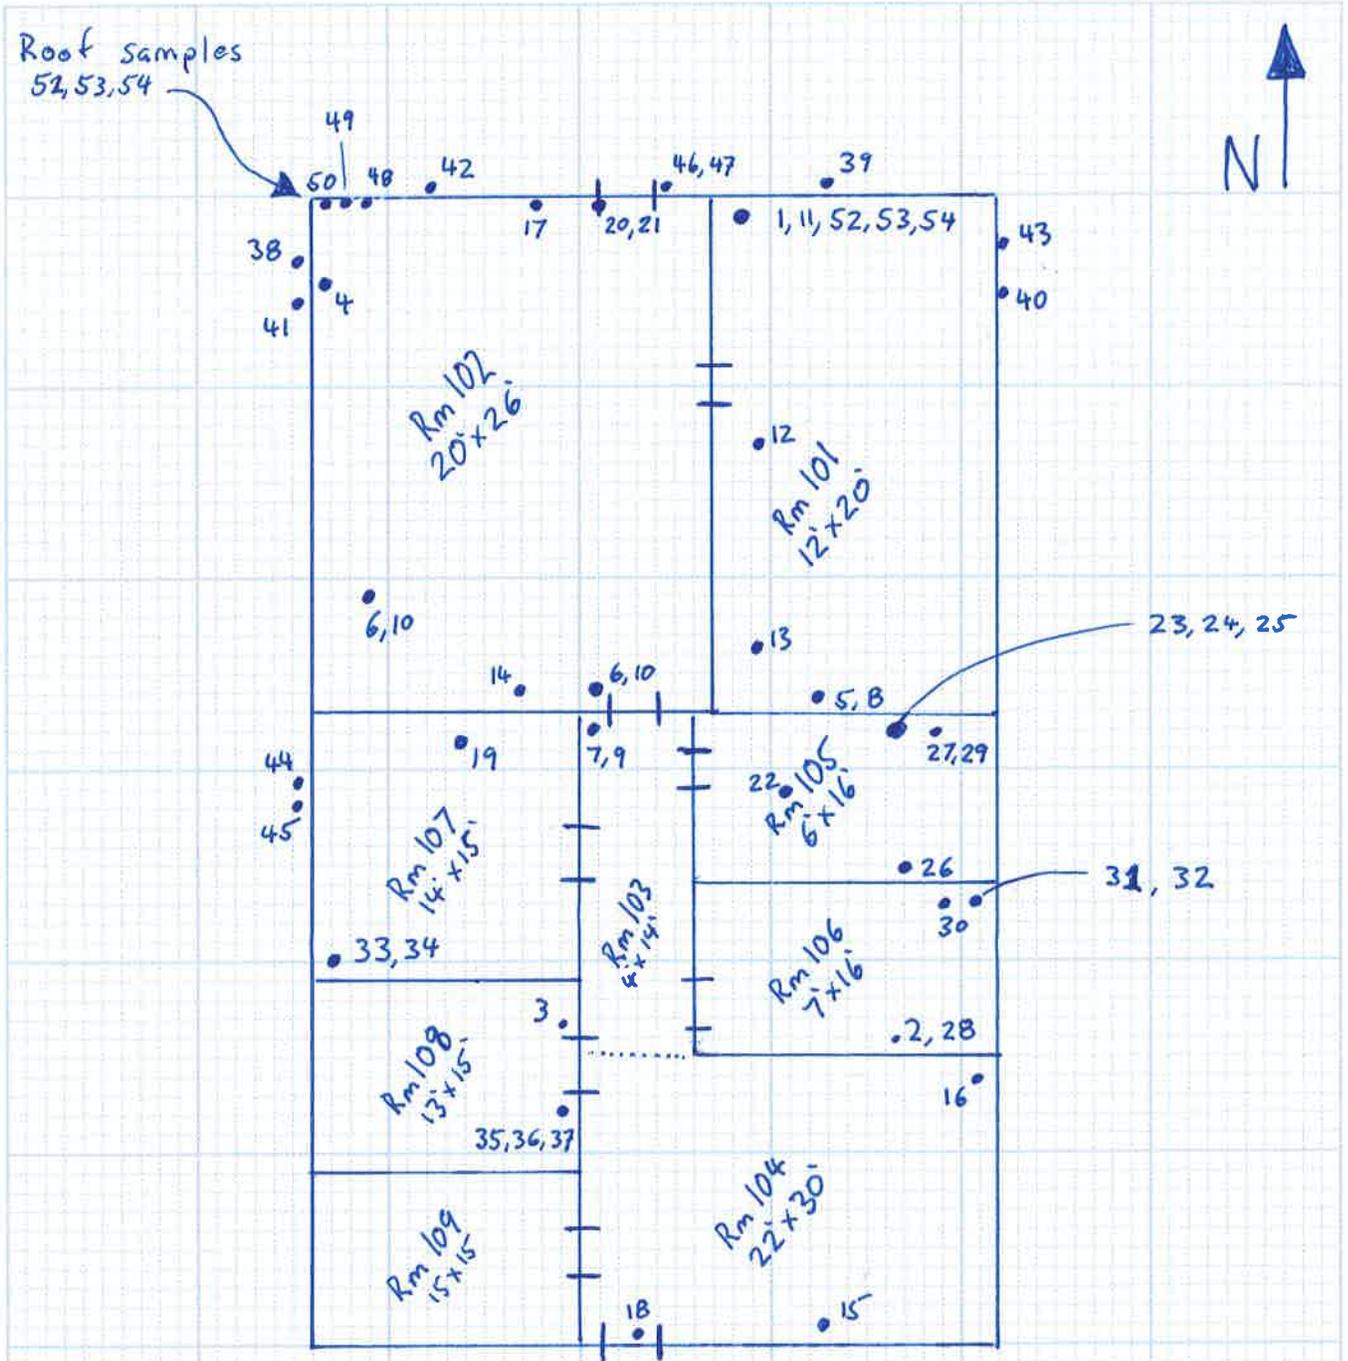
FIGURE 2

Building #1 sample locations 1-50, 52-54

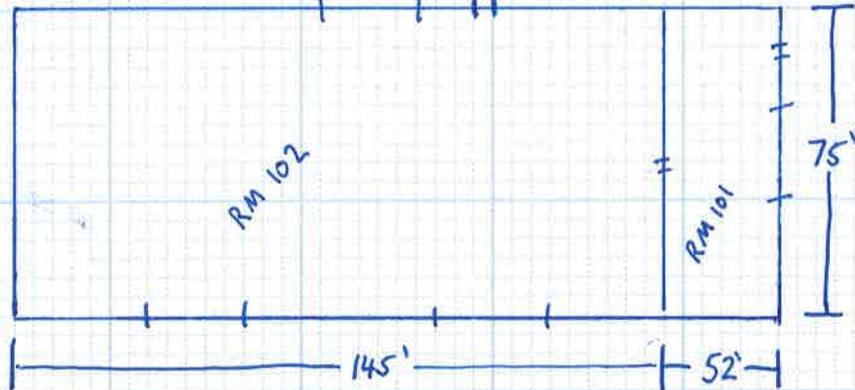
Building #4

No samples collected - while not observed, a potential for seam tar exists between exterior metal panels.

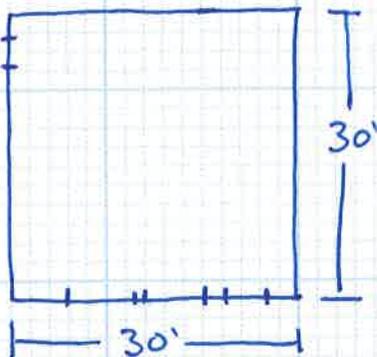
Building #9

No samples collected.
