STRUCTURAL CONDITION SURVEY
OF
JEFFERSON COUNTY SHERIFF'S ANNEX BUILDING
FOR

JEFFERSON COUNTY
320 SOUTH MAIN STREET
JEFFERSON, WISCONSIN

SEPTEMBER 18, 2012

Jefferson County Sheriffs Annex Building Structural Condition Study

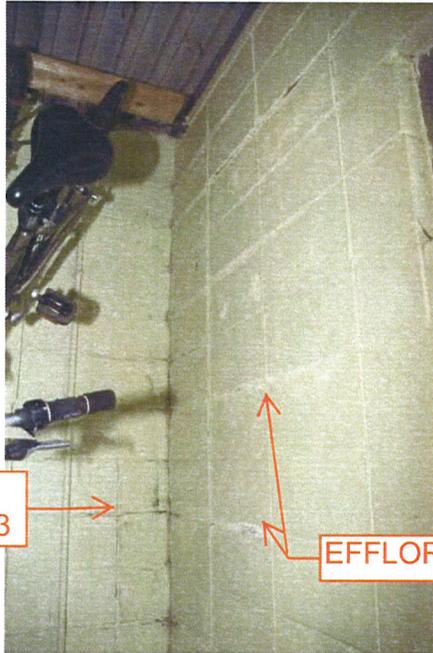
2.1 INTERIOR-SW CORNER OF EVIDENCE ROOM

Mildew is present in the deteriorated corner of the evidence room. This most likely is caused by the excessive moisture within the wall. The existing HVAC system service to this room should be reviewed, monitored and if required modifications should be made to increase air flow to reduce humidity in this room.

MILDEW @
CORNER SEE 2.3

EFFLORESCENCE

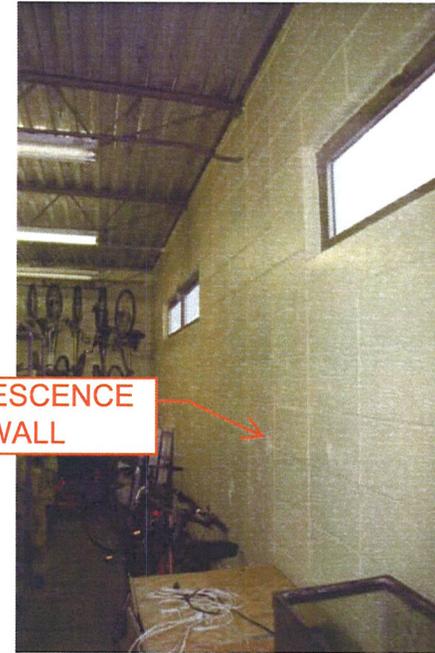
2.2 INTERIOR-W WALL OF EVIDENCE ROOM

The Interior face of the CMU walls are in good condition with some mortar joints requiring tuck-pointing. Water vapor drive has blistered areas of the interior paint coating concentrated lower 1/3 the wall, with efflorescent deposits on the underlying CMU. The efflorescent deposits can be removed for recoating with chemical washes available from masonry restoration chemical suppliers.

EFFLORESCENCE
ALONG WALL

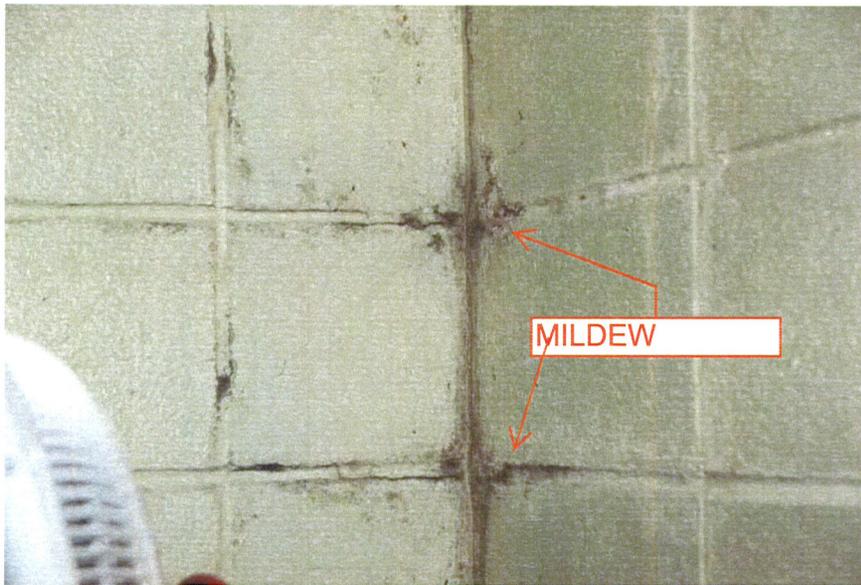
2.1 INTERIOR-SW CORNER OF EVIDENCE ROOM

MILDEW

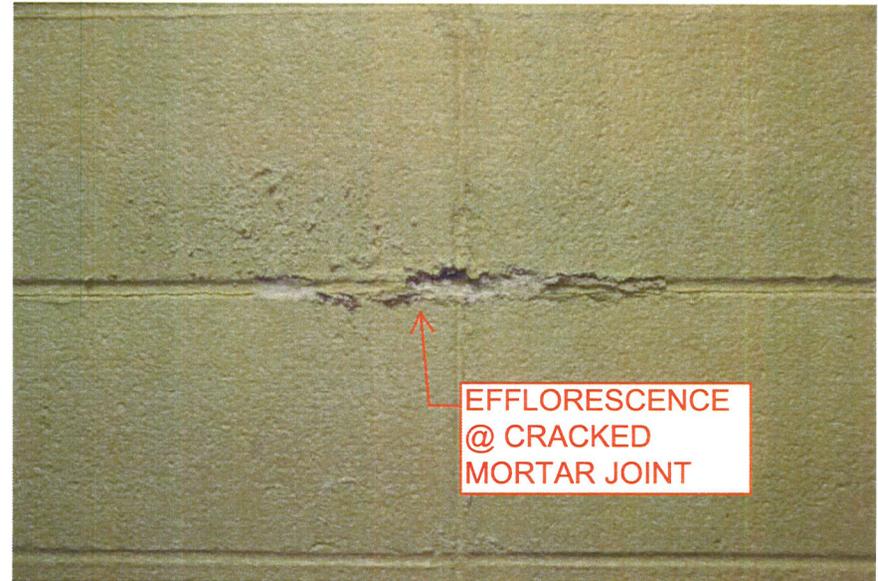
2.2 INTERIOR-W WALL OF EVIDENCE ROOM

EFFLORESCENCE
@ CRACKED
MORTAR JOINT

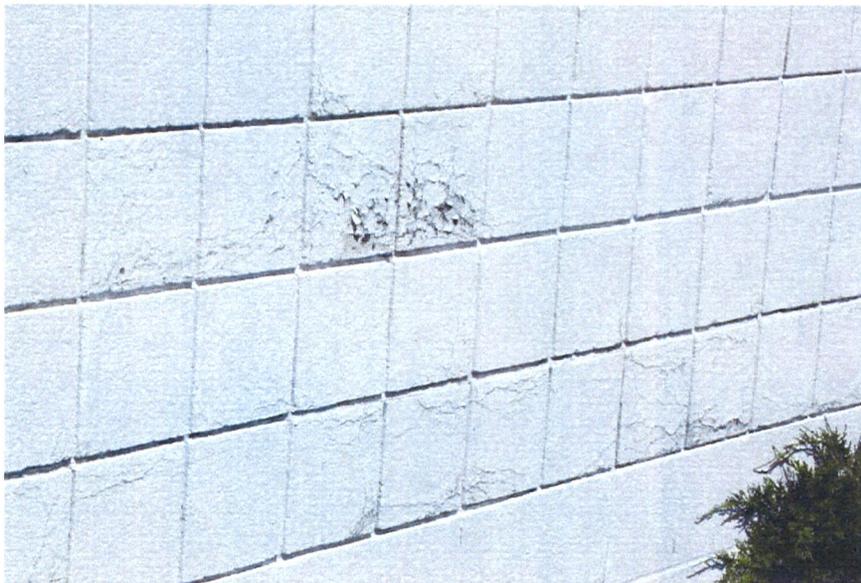
The white coating on the exterior walls has extensive areas of blistering, cracking. The unknown coating product should be tested by a laboratory to identify the type of coating and possible lead content. The analysis of this coating will be required to establish the lead content to conform environmental regulations and OSHA requirements for the removal of damaged coating areas. Field testing of different types of surface preparation and removal operations, including pull off tests, will be required to assure bonding of the recommended spray applied moisture barrier to the existing coating.

6.3 EAST ELEVATION -BLISTERING & CRACKED PAINT

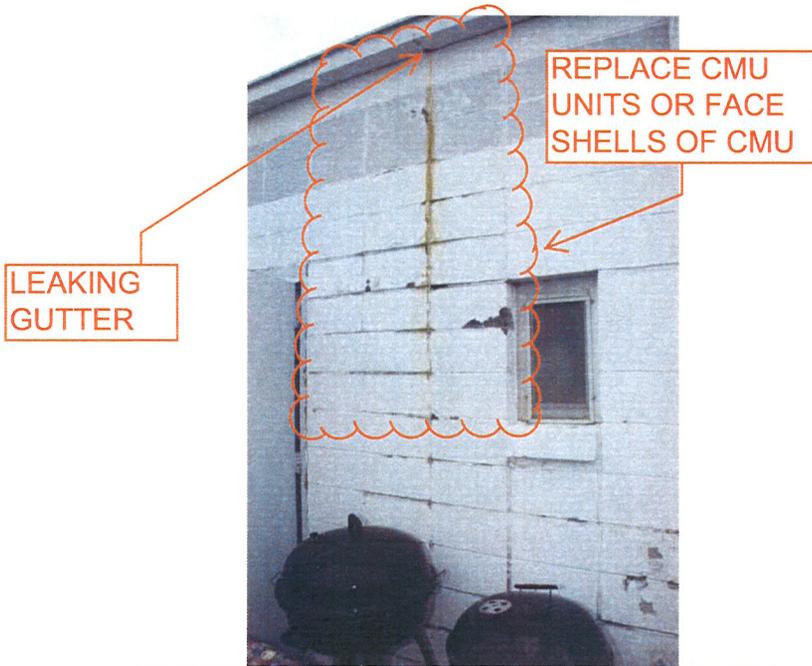
Leaking of gutters and damaged sections of downspouts have caused damage to the wall system. These systems should be replaced.

11.1 DAMAGE FROM LEAKING GUTTER
